# Development and Application of BEOL Polymer Residue Removal Technology

<sup>1</sup> ACM Research (Shanghai), Inc., Pudong, Shanghai, China

<sup>2</sup> Anji Microelectronics (Shanghai) Co.,Ltd., Pudong, Shanghai, China

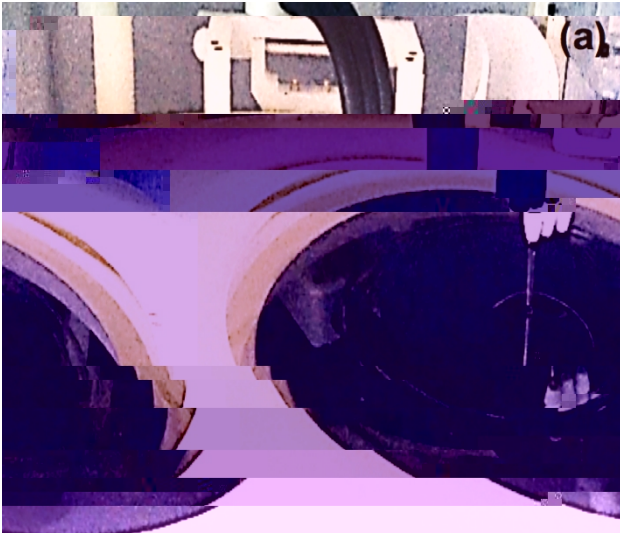
Fig. 6. (a) Captured image of ST250 layer thickness at a rotation rates of 400 rpm. (b) Water layer thickness profiles at the rotation rates of 200, 500 and 1400 rpm respectively [4].

Hypothesis 1:  
Hitoshi et al. found that in single-wafer wet cleaner, the local thickness of water layer is related to various parameters, such as wafer rotation speed and radical distance from wafer center [4]. As shown in Fig. 6(b), at the rotation rates of 200, 500 and 1400 rpm, the water layer thickness does not present steady curves as the radical distance changes. At the radial distance from wafer center of around 10mm, both liquid layer thickness and the radical velocity are much smaller than other zones (radical velocity profile is not shown). We suspected that the combination of thinner liquid layer thickness and slower radical velocity will result in poor chemical wetting at this local area, which consequently results in ball-type defect deposition. This phenomenon is more pronounced to high-viscosity chemical, such as ST250. The captured image in Fig. 6(a) also confirms this prediction. As shown in Table 1, viscosity of ICS8000 is much lower than ST250’s, which is the reason why ICS8000 does not suffer the ball-type defects (Fig. 5).
